## TEST REPORT

No. : XMIN1502000774ML

Sample Name : RAIL-01  
Product Specification : 40  
Manufacturer : Xiamen Solar First Energy Technology Co.,Ltd  
Buyer : Xiamen Solar First Energy Technology Co.,Ltd  
Material and Mark : AL6005-T5  
Other Information : SF-R01  
Date of Receipt : Feb 05, 2015  
Testing Start Date : Feb 05, 2015  
Testing End Date : Feb 12, 2015  
Test result(s) : For further details, please refer to the following page(s)

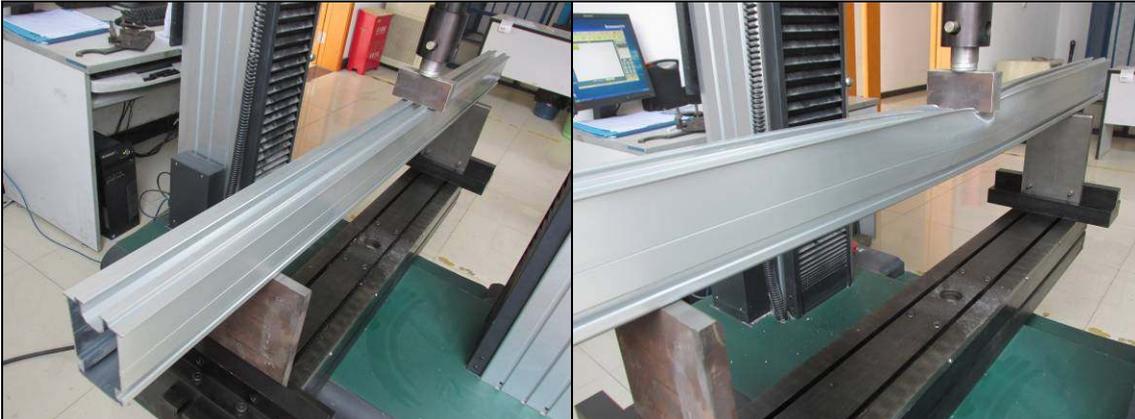
Test Photo:

Photo 1: before loading

Photo 2: the moment of destruction

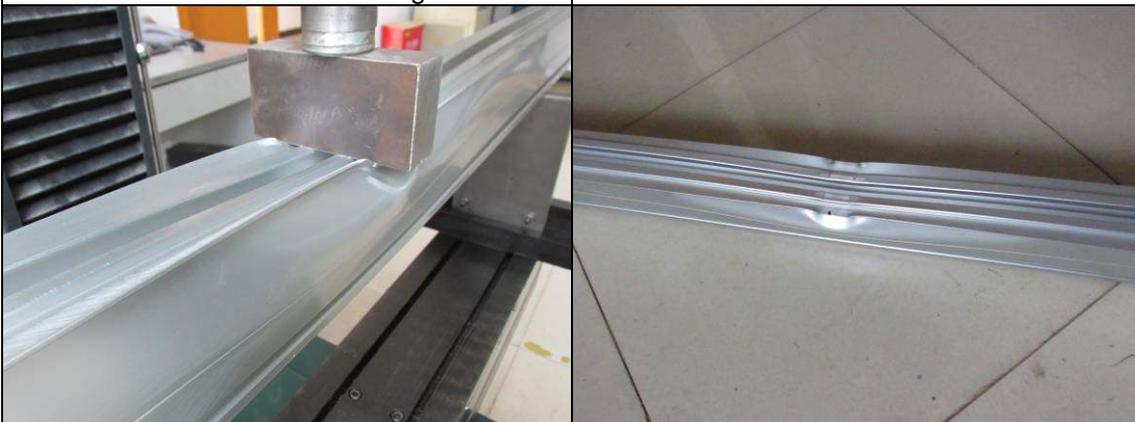
Photo 3: destroyed part

Photo 4: sample after test
